# COMPREHENSIVE ASBESTOS AND LEAD-BASED PAINT XRF SURVEY REPORT

**COMPTON COMMUNITY COLLEGE  
ADMINISTRATIVE BUILDING  
1111 EAST ARTESIA BOULEVARD  
COMPTON, CALIFORNIA 90221**

Bainbridge Project #: 18016255.12  
January 18, 2018

**RE: Phase 1 – Comprehensive Asbestos and Lead-Based Paint XRF Survey Report for Compton Community College – Administrative Building located at 1111 East Artesia Boulevard, Compton, California 90221.**

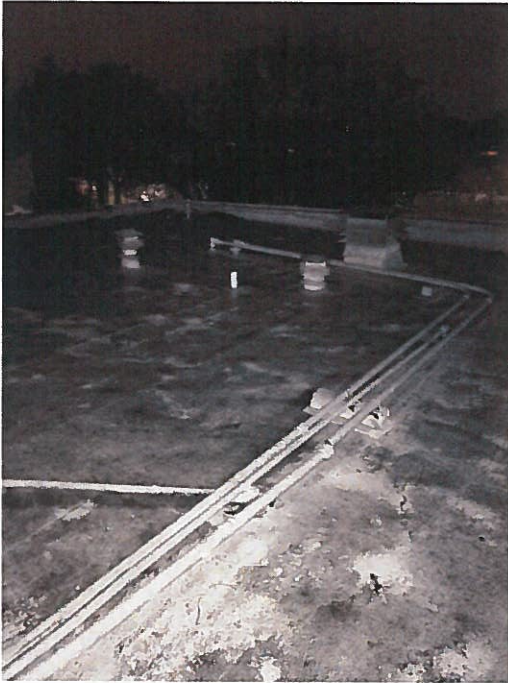
Overview of Lower Roof

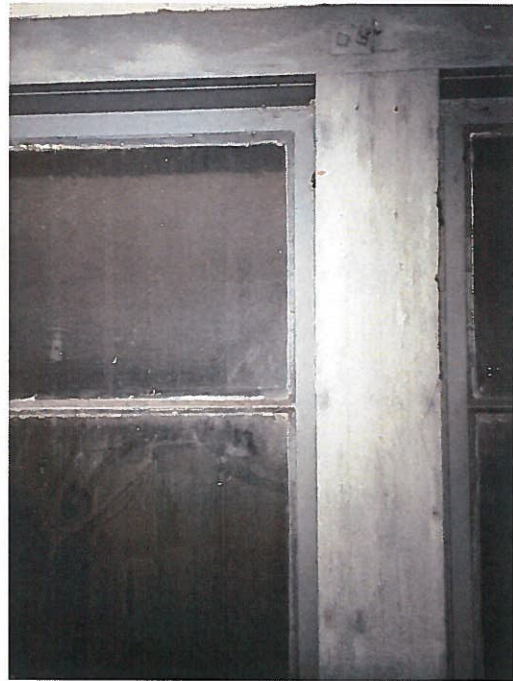
View of Window Putty

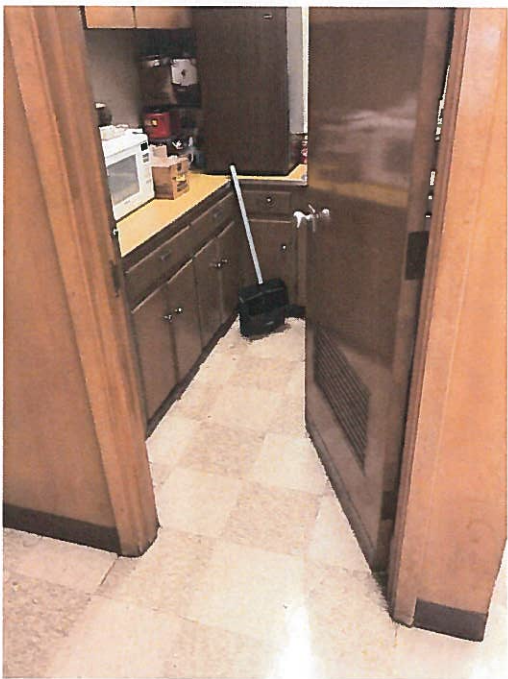
12"x 12" Tan and Light Tan Floor Tile in  
Little Kitchen

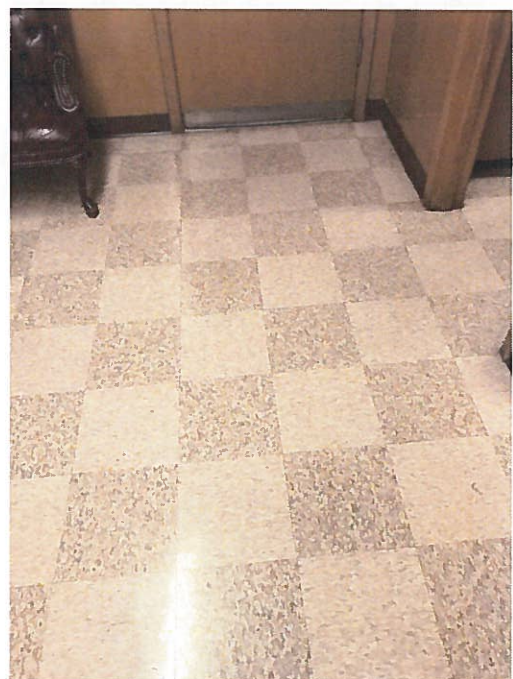
87-Floor Tile 2	Office Adjacent to CEO South	12"x12" Floor Tile w/Mastic (with Green Floor Tile w/Mastic Underneath)	Tan w/ Streaks	Good	Non-Friable	See Above	Included Above	5% Chrysotile

12"x 12" Tan and Light Tan Floor Tile in  
Office adjacent CEO's Office

- Identified asbestos-containing materials must be removed prior to any scheduled renovation or demolition activities in adherence with South Coast Air Quality Management District (SCAQMD) regulations (Rule 1403).

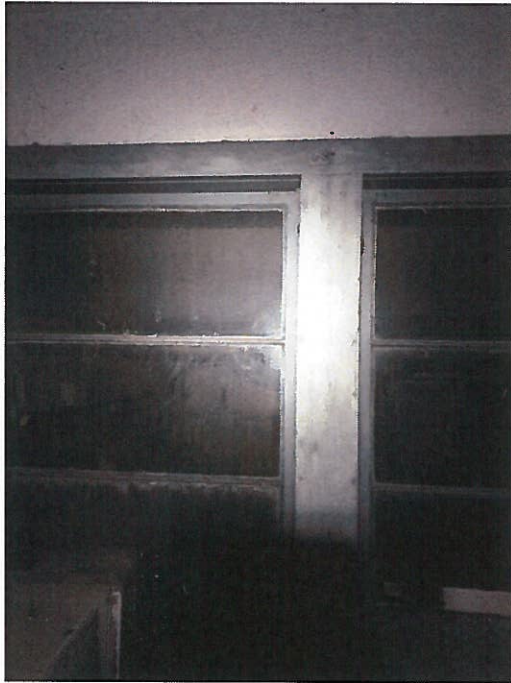
View of Window Putty

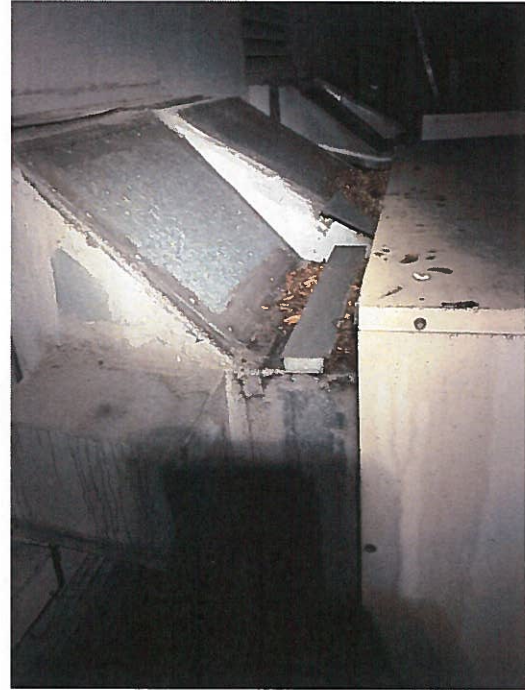
View of Ducting Mastic

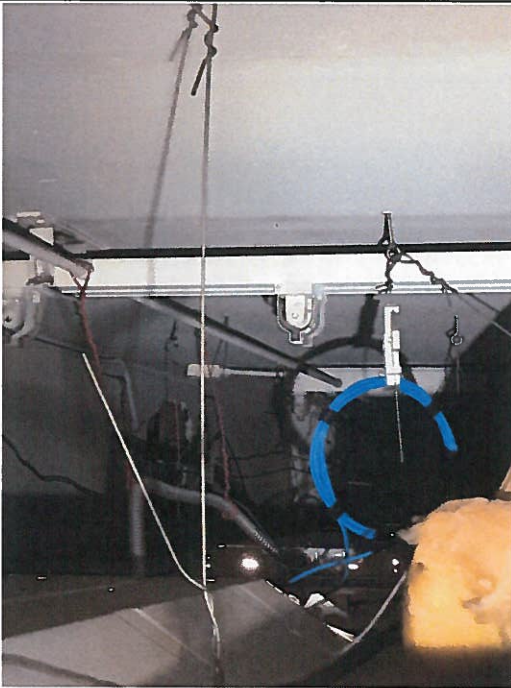
Ceiling above 2'x 4' Fissured Ceiling Tile in Board Room

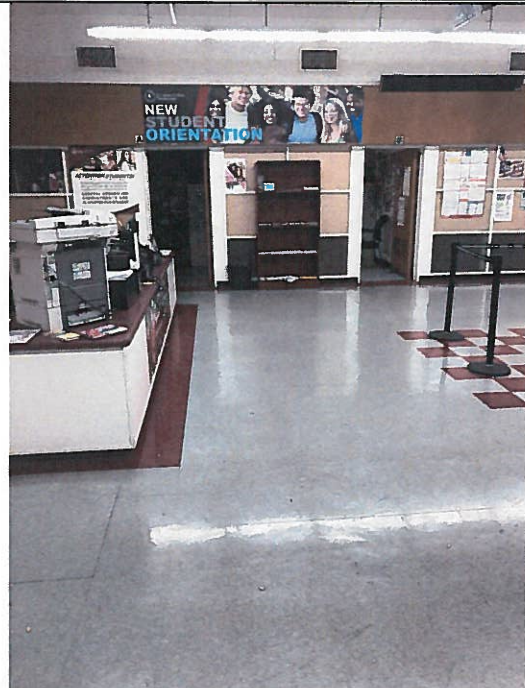
12"x 12" Red and Light Blue w/Streaks Floor Tile in Reception Lobby

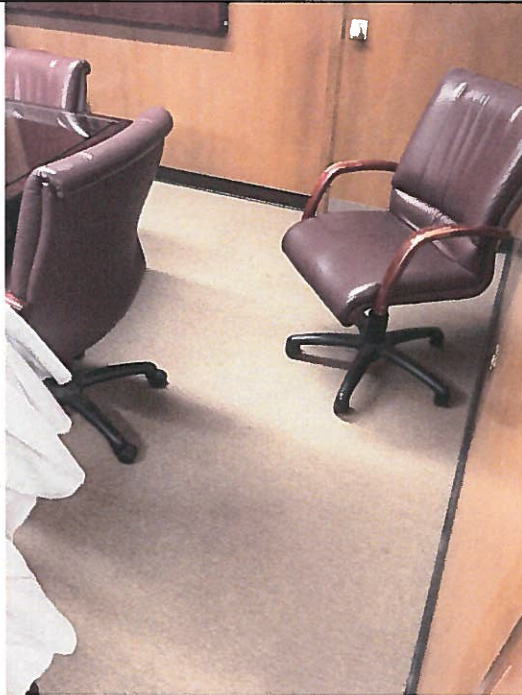
4" Black Base Cove and Carpet in Board Room

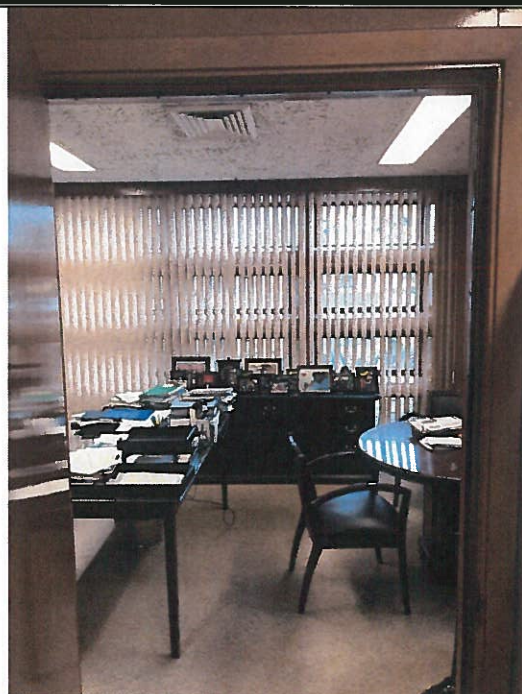
12"x 12" Textured Ceiling Tile in CEO's Office
