# COMPREHENSIVE ASBESTOS AND LEAD-BASED PAINT XRF SURVEY REPORT

**COMPTON COMMUNITY COLLEGE  
ADMINISTRATIVE BUILDING  
1111 EAST ARTESIA BOULEVARD  
COMPTON, CALIFORNIA 90221**

Bainbridge Project #: 18016255.12  
January 18, 2018

**RE: Phase 1 – Comprehensive Asbestos and Lead-Based Paint XRF Survey Report for Compton Community College – Administrative Building located at 1111 East Artesia Boulevard, Compton, California 90221.**

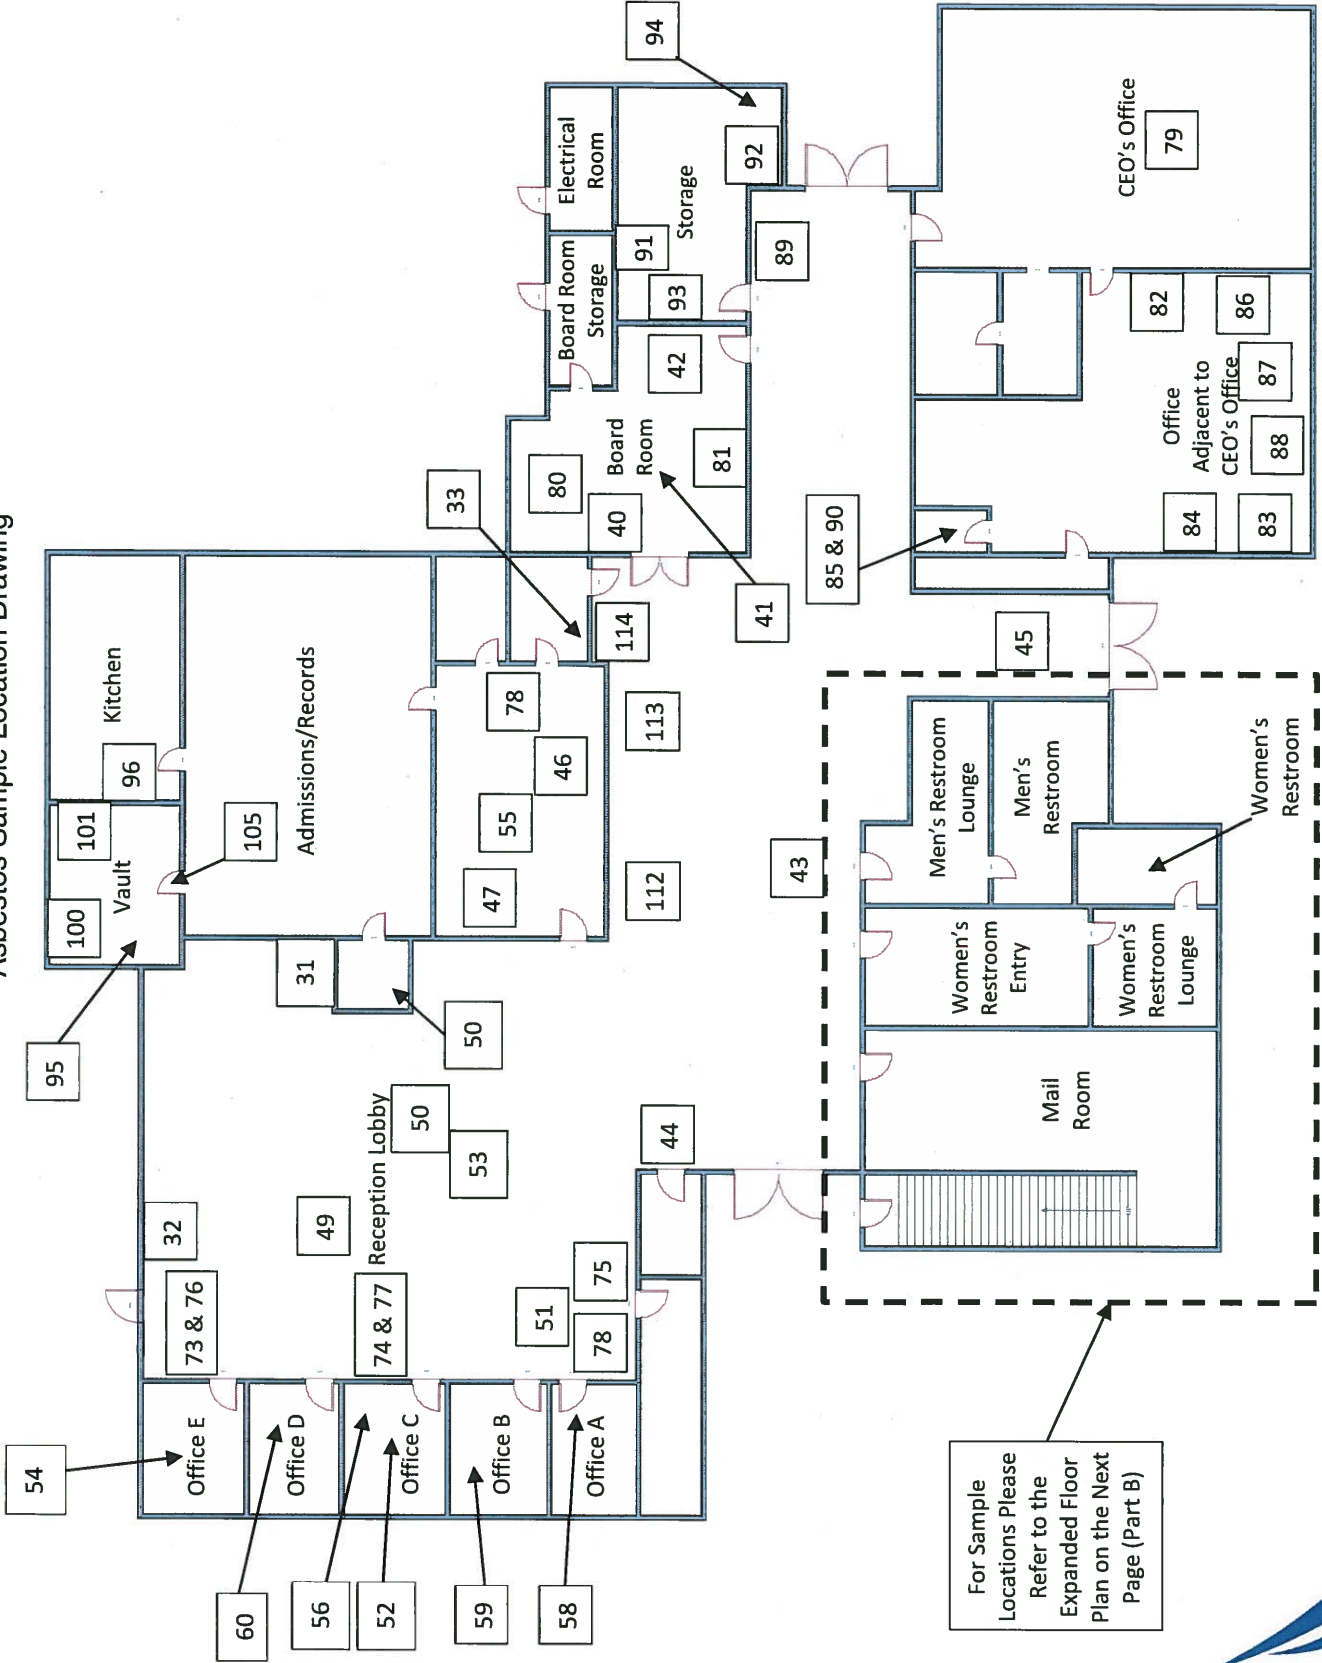
Compton Community College District  
 Compton Community College – Administrative Building (Part A)  
 Asbestos Sample Location Drawing

For Sample Locations Please Refer to the Expanded Floor Plan on the Next Page (Part B)
